# What we used and *why*

Material selections for our Woolsey Fire rebuild based on  
priority criteria

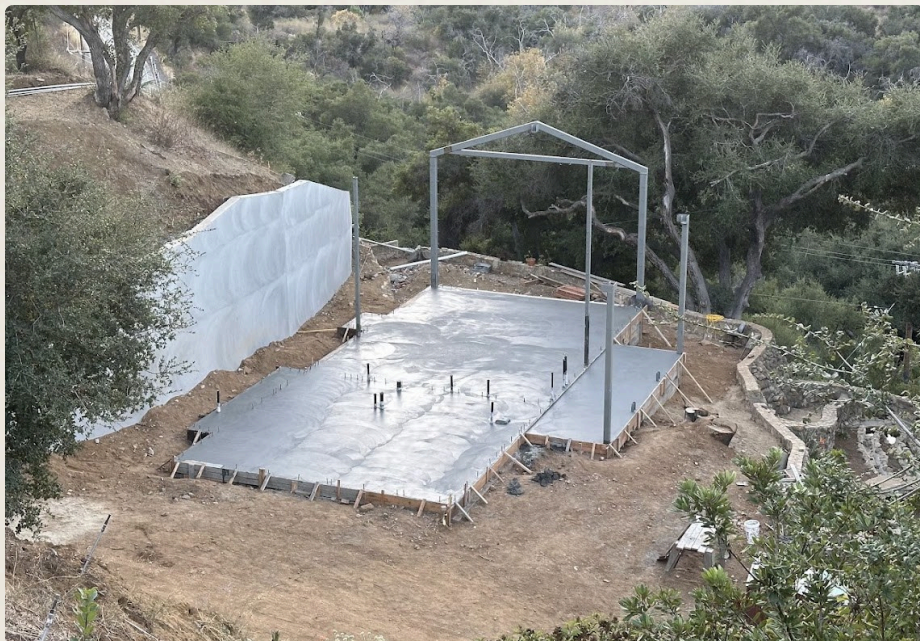
# Foundation

Steel reinforced, CARB-compliant, regionally sourced concrete poured over the existing slab

Reinforced concrete slab was highly feasible to design and permit. Laying it over our existing 55+ year old slab also allowed us to avoid a grading permit for the main house.

Our highly experienced concrete contractor put it this way: the only way this foundation will ever fail is if the whole mountain slides away.

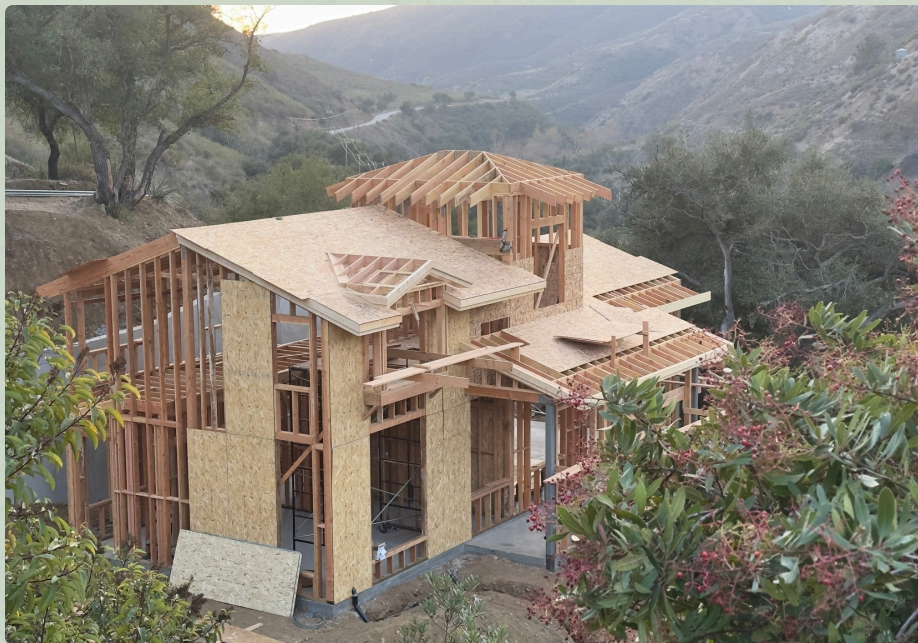
# Framing

Wood stick-built with OSB shear walls and steel-beam reinforcement at large openings, anchored to the foundation, and designed to exceed code for life safety and seismic damage.

Seismic resistance is high, while fire resistance becomes high with the rest of the wall system (see section 2).

Breathable wood framing helps prevent trapped moisture and mold. Untreated wood and steel minimize off-gassing. A few glulam beams off-gassed early in construction, before occupancy, and a vinegar-based wash was used to inhibit mold.

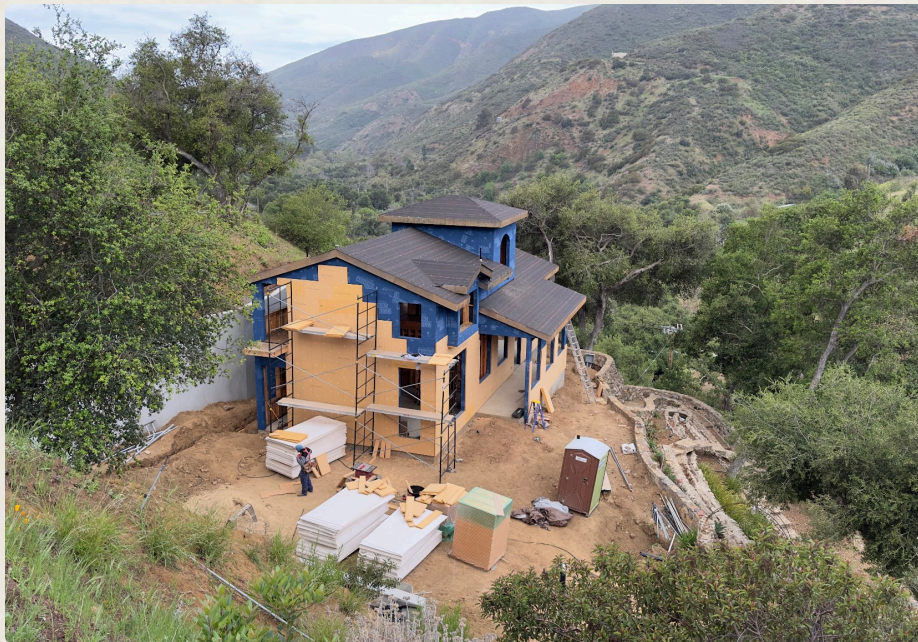
# Sheathing

OSB and Plywood.

OSB and plywood are seismically resistant, and while combustible if exposed, they are enclosed in a highly fire-resistant wall system.

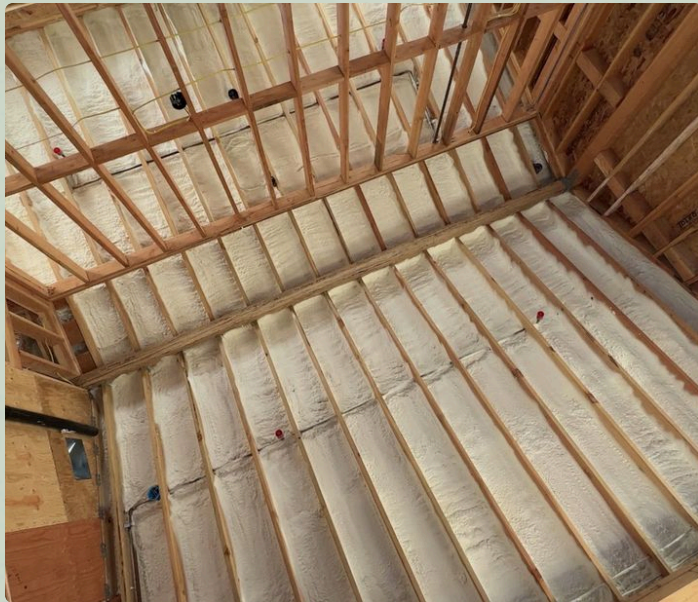
Ceiling: soy-based, low-Global Warming Potential (GWP) closed-cell spray foam (Huntsman Heatlok HFO EZ)

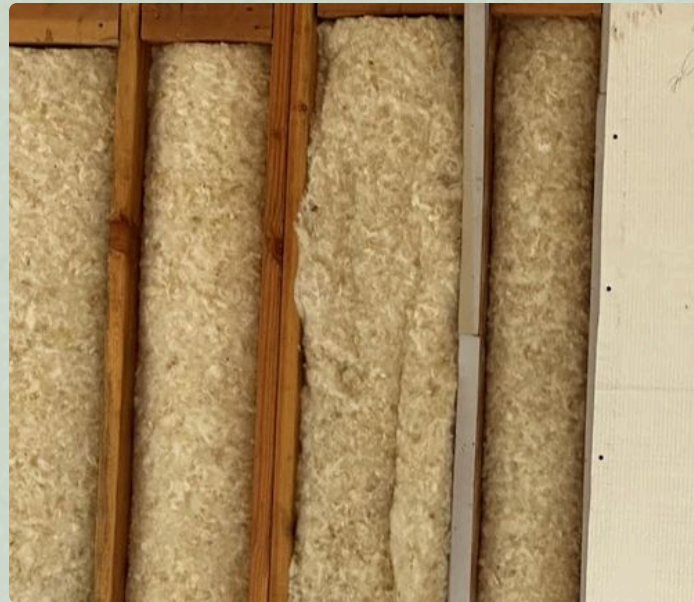
Ceiling & walls: Havelock R22 sheep wool batt

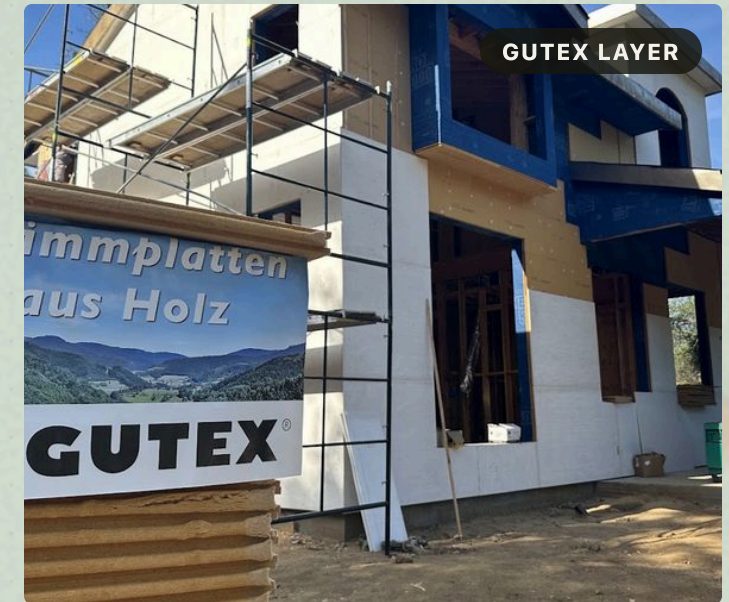
Walls: Gutex Multitherm 40mm / 1.57" wood-fiber board

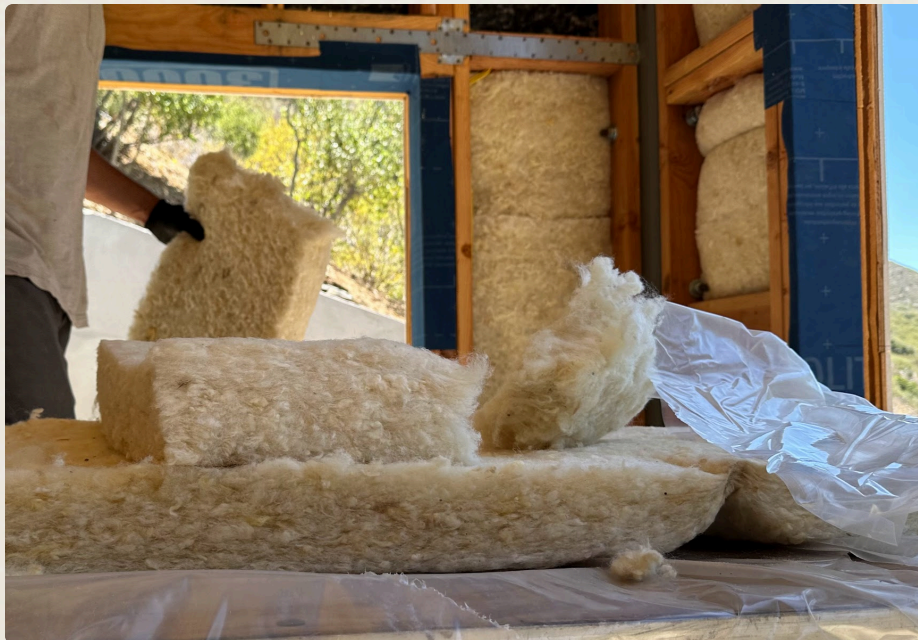
# Insulation

Ceiling: low GWP spray foam + wool batt. Walls: wool batt + Gutex wood fiber

Spray foam and sheep wool are Class A fire rated; Gutex wood fiber is less fire resistant, but all insulation materials are tightly covered by non-combustible materials, making their overall disaster resistance high.

Foam use, while hazardous to workers, was minimized to only 1.5 inches and well-ventilated during installation, and importantly helps prevent condensation and mold. Wool and wood fiber are nontoxic and breathable.

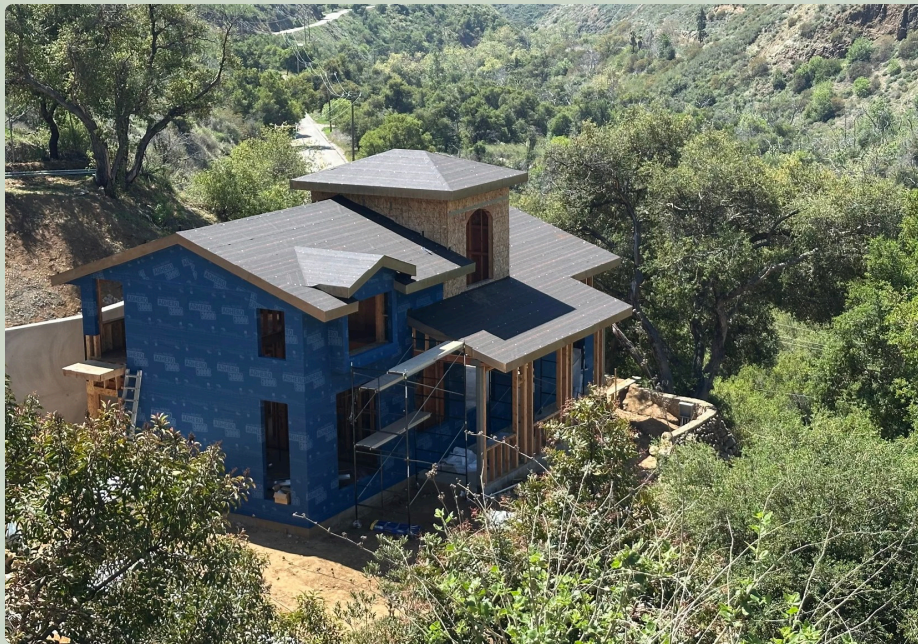
# Air barrier

Pro Clima Adhero 3000, taped around every opening

Its smart membrane keeps vapor out in cool wet weather and in during dry weather, supporting a healthy indoor climate.

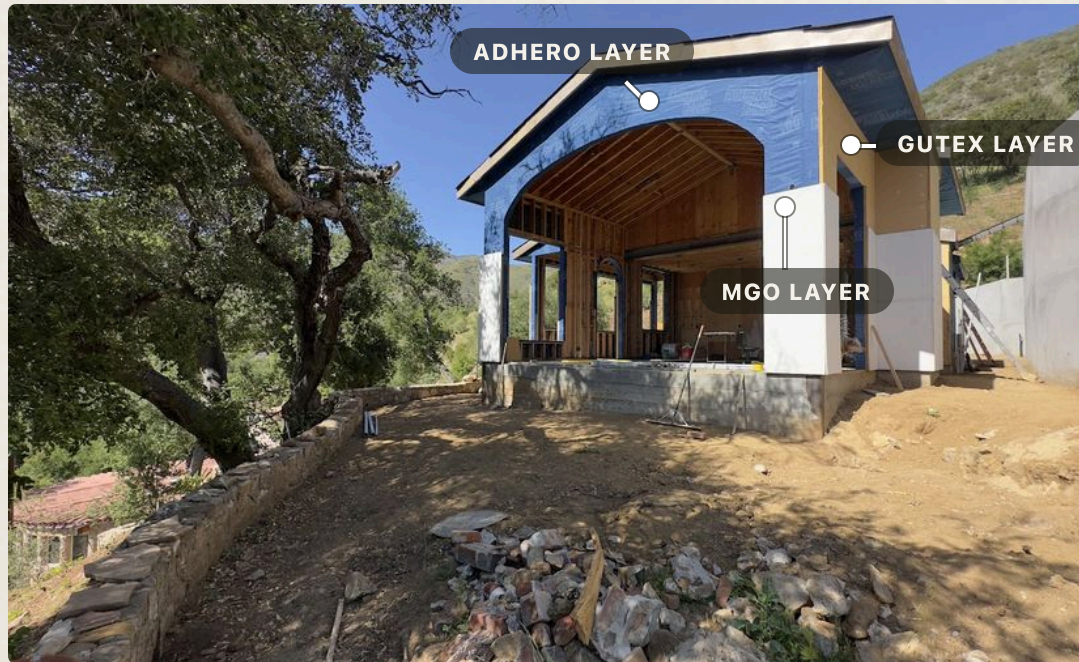
Living room window, with Adhero 3000 (over Gutex not visible in photo), then covered by MGO

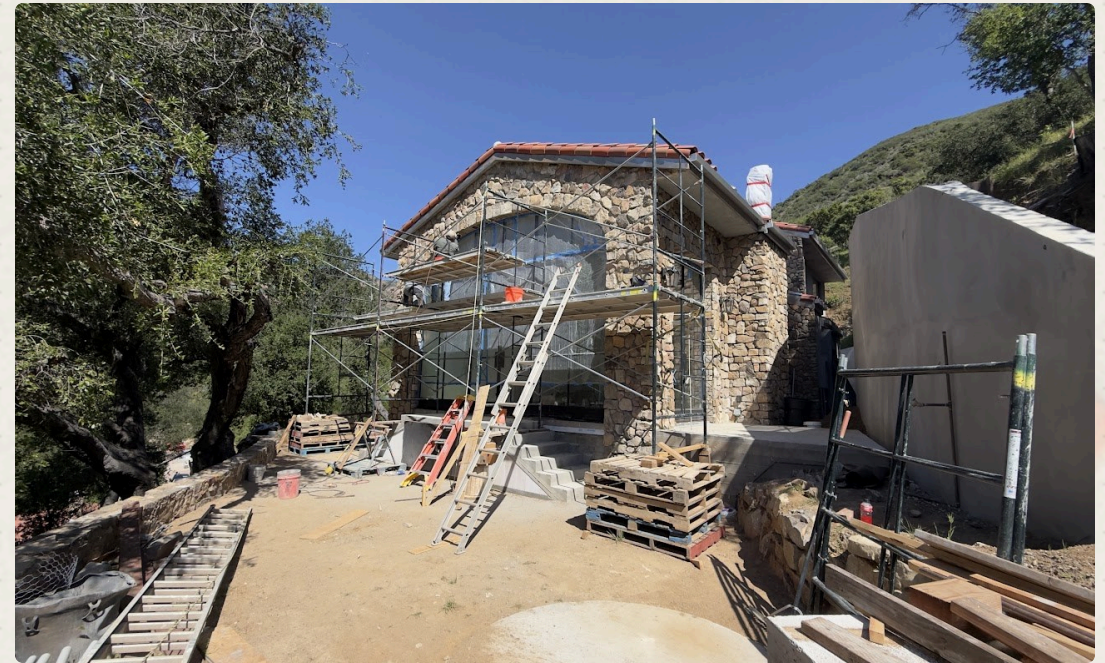
Stone veneer applied with mortar and anchors over MGO is the final exterior layer.

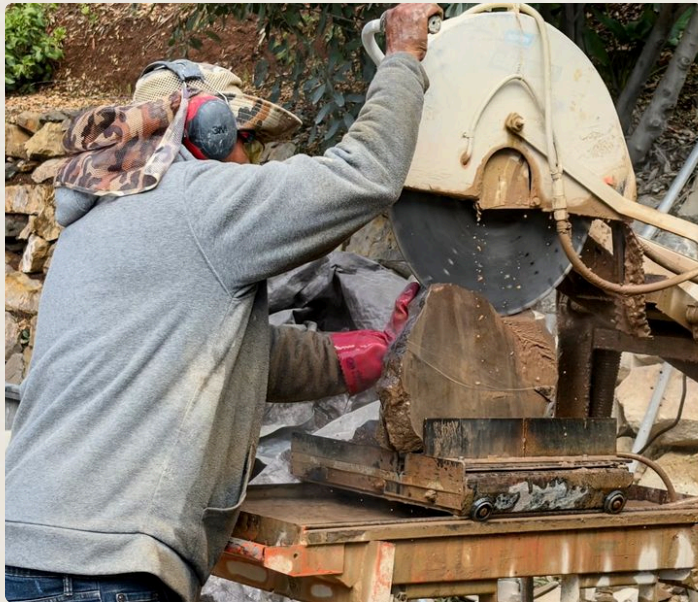
Salvaged stone, cut to fit on-site with water-cooled saws. We got a great deal on a local used saw on Facebook Marketplace!

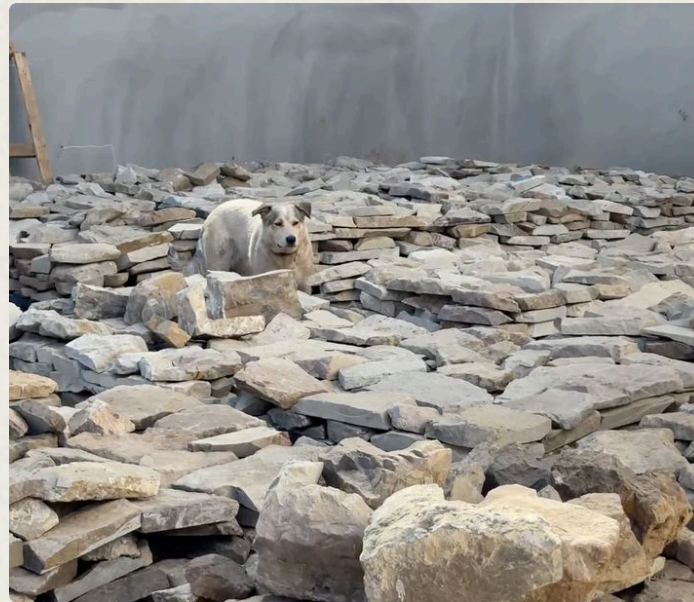
Cut stone staged by pallet, ready for installation

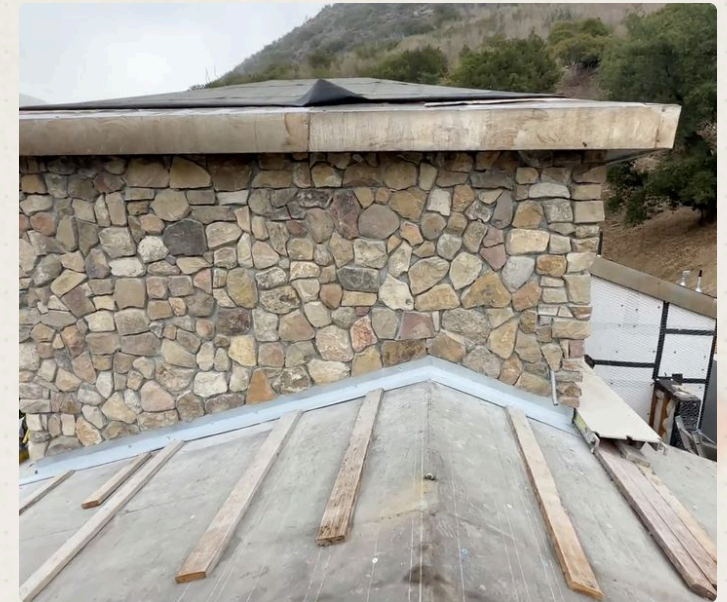
Set by hand over wire lath by a master mason and crew

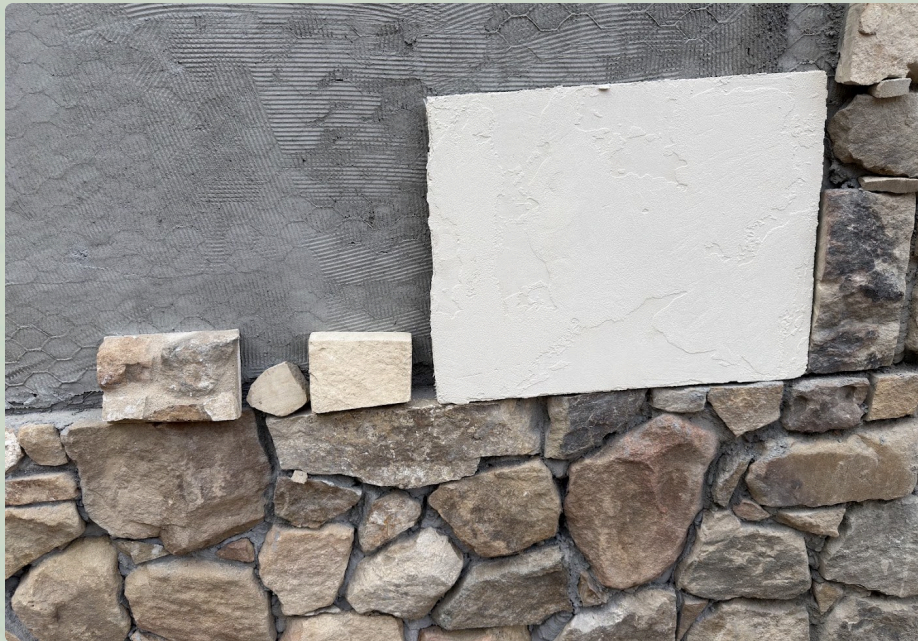
# Exterior siding

2" salvaged sandstone veneer, cut on-site from stones collected on-site and on the road after storms (85-90% of exterior); lime plaster (10-15% of the exterior). Both over ½" magnesium oxide (MgO) board.

Testing limestone stucco samples with our salvaged stone veneer

Stone and MgO are non-combustible; thin, anchored stone follows seismic best practice. Lime plaster is also non-combustible.

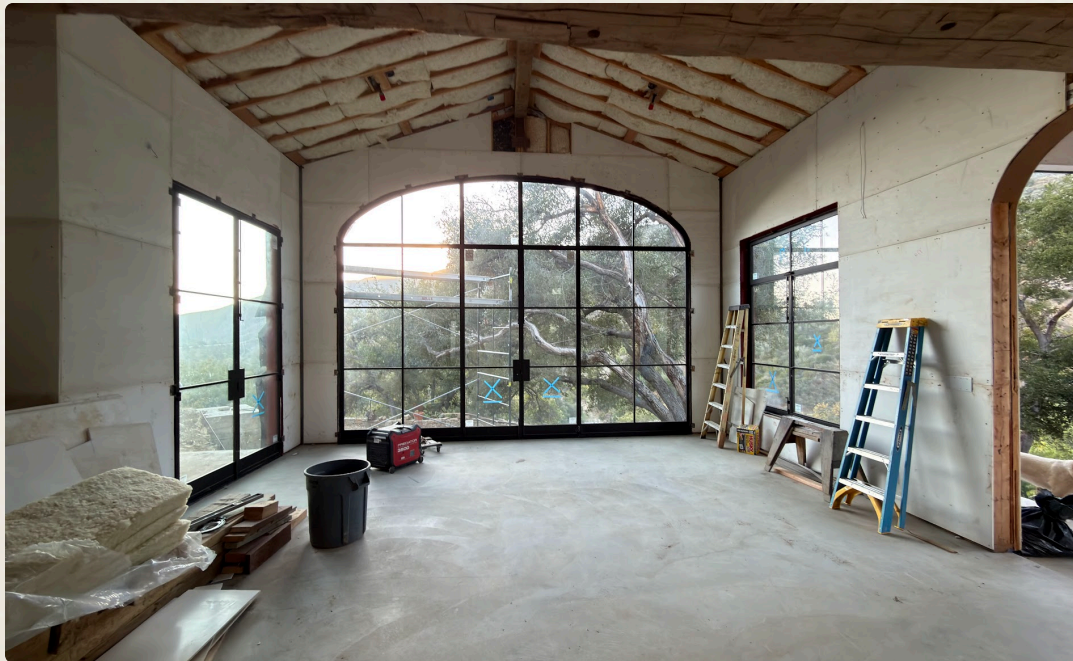
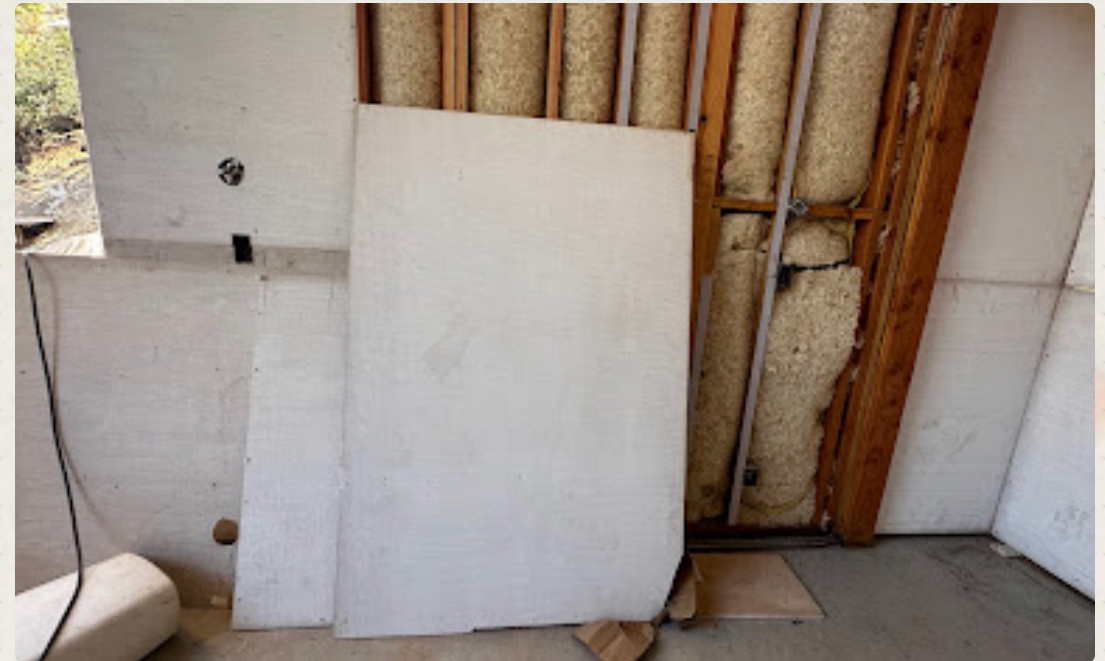
# Interior wall base layer

Magnesium oxide (MgO) board

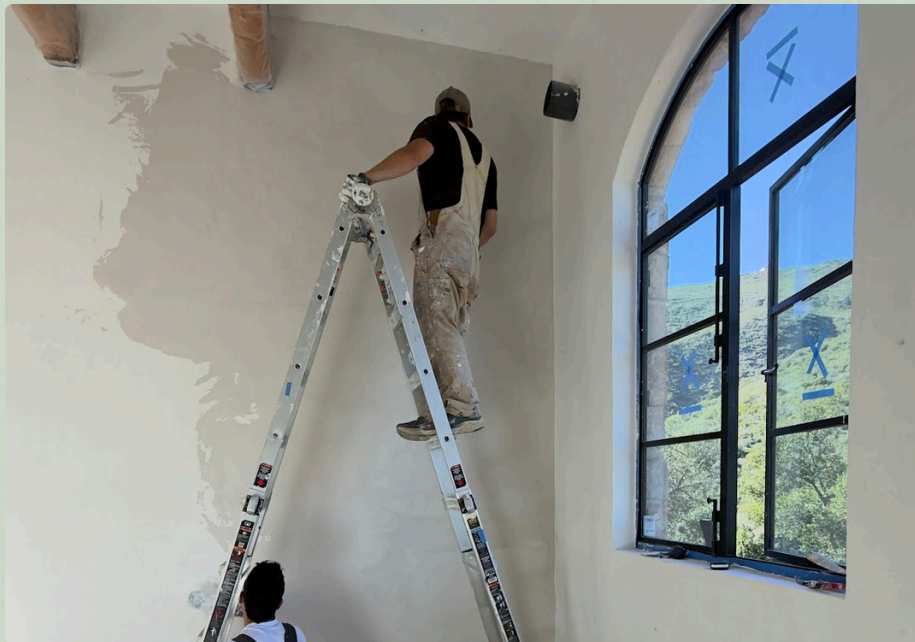
## Lime Plaster

Lime plaster is non-combustible.

Nontoxic and breathable, lime plaster supports good indoor air quality.

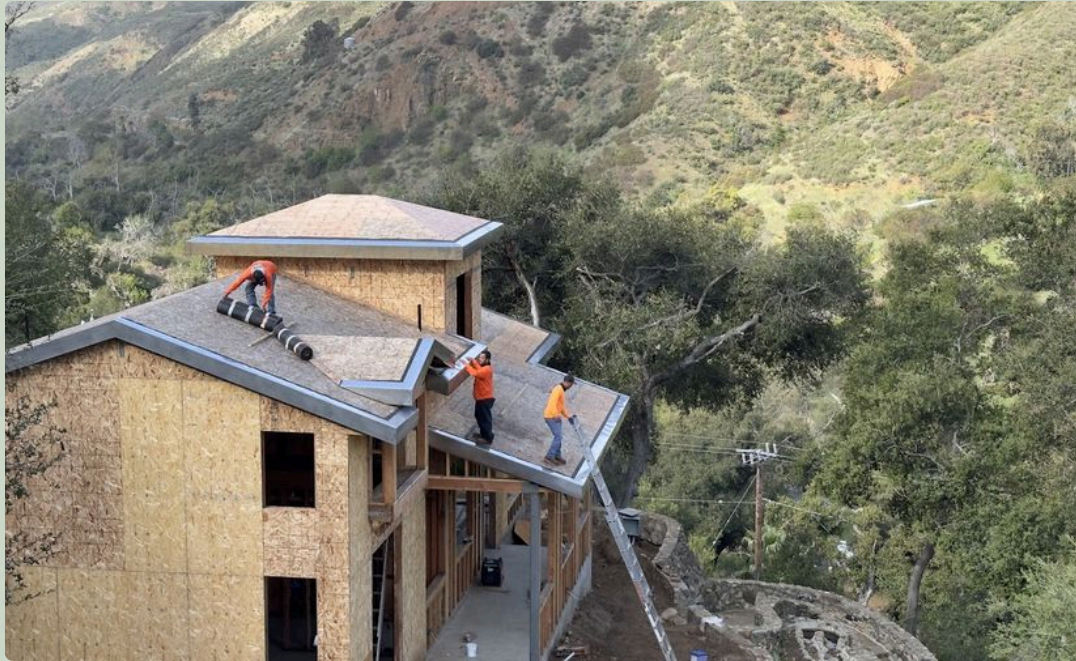
Polystick XFR WUI underlayment on the non-vented roof

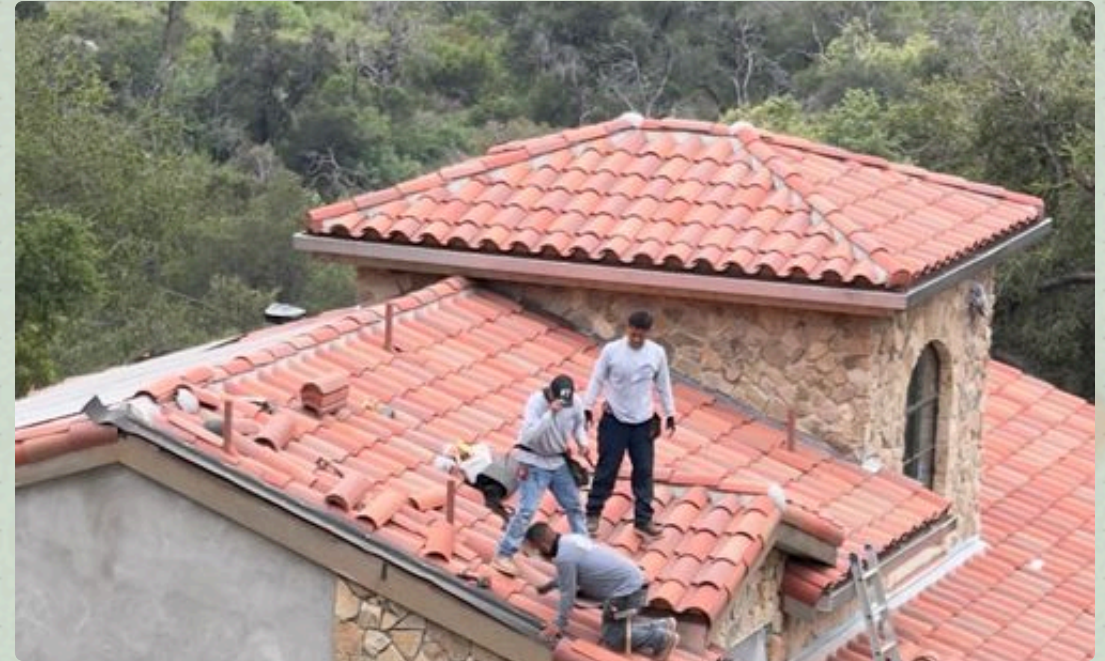
Mission clay roof tile being installed

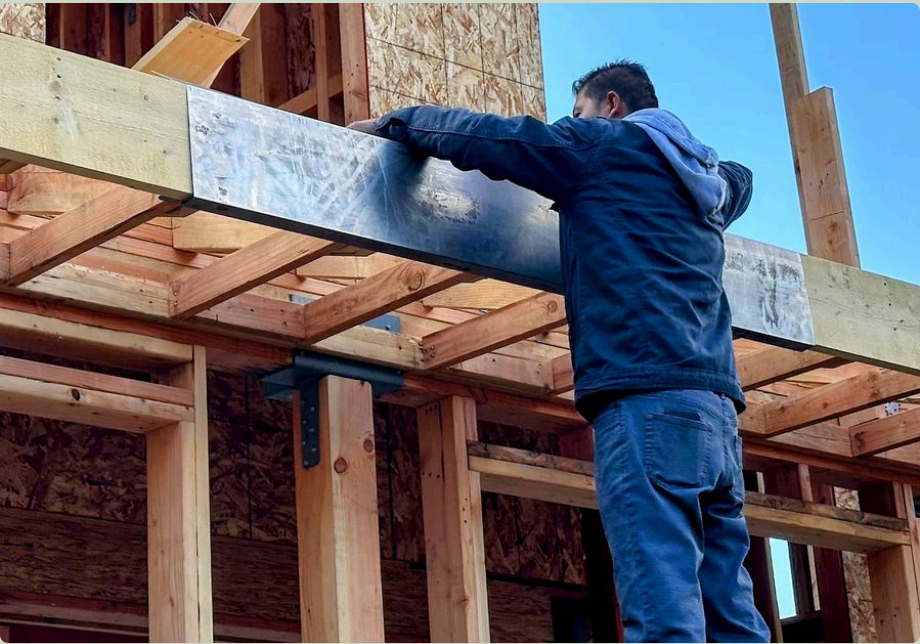
# Fascia

## Stainless steel sheet

Steel is non-combustible and slower to melt in fire than aluminum.
- ♥️

Not toxic — we rusted it with a salt-vinegar solution and seal it with a non-toxic sealant.
- 💰

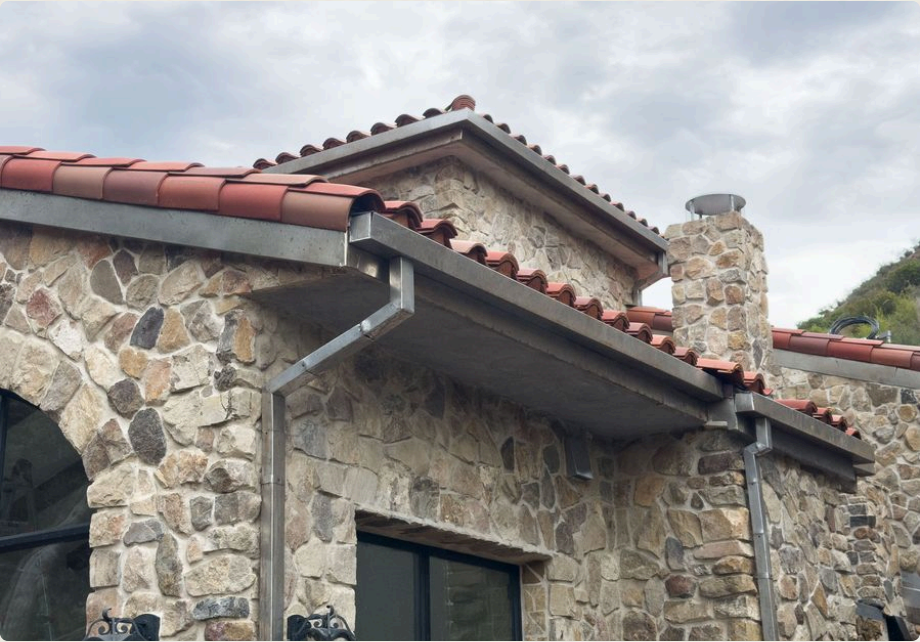
# Downspouts & gutters

Stainless steel with steel mesh

Steel is non-combustible, and the mesh prevents fire prone debris and embers from collecting.
- ♥️

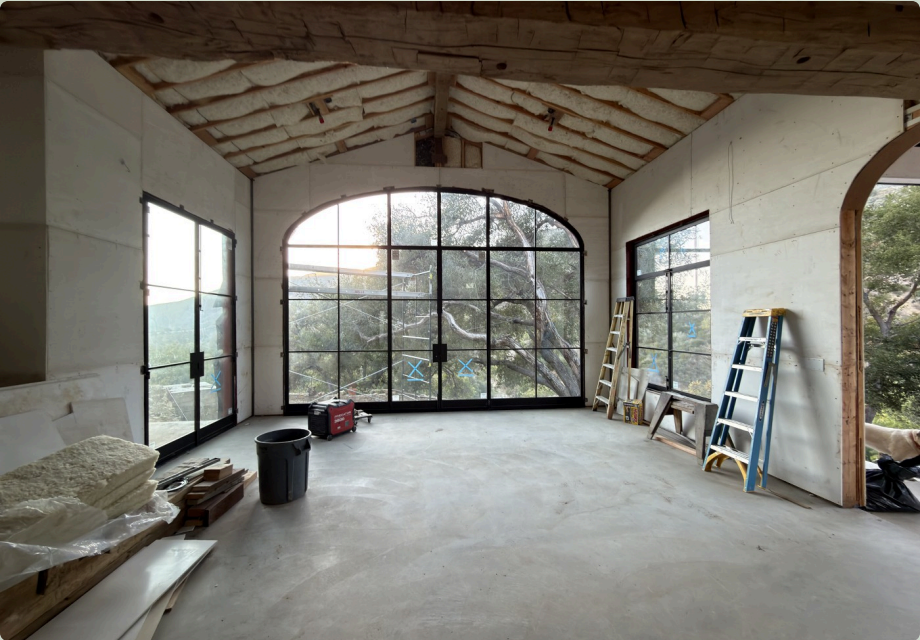
# Windows

Hot-dipped galvanized steel frames with dual-pane, tempered, 99% UV-protective laminated glass, sealed with fire-resistant adhesive and Prosoco waterproofing

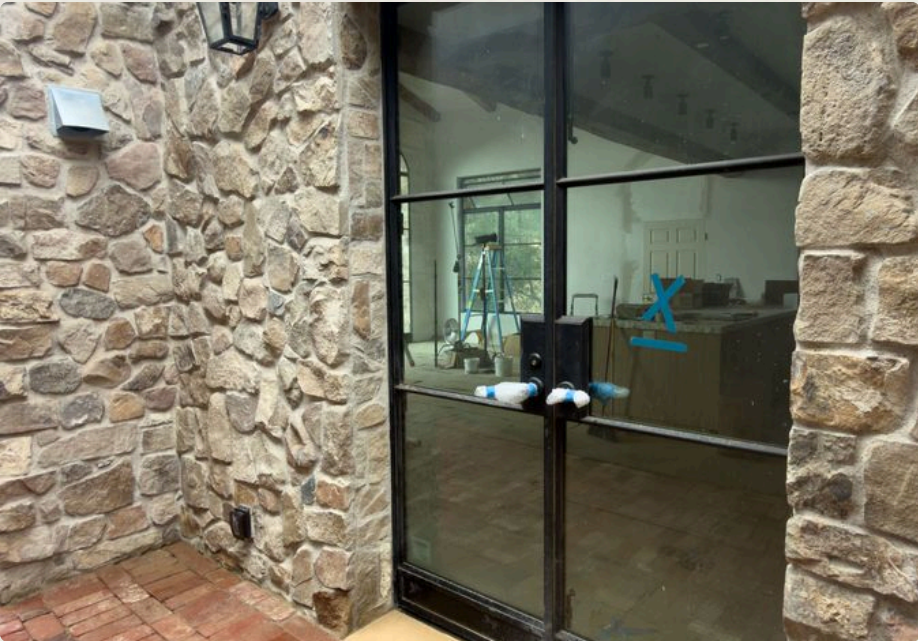
# Doors

Same specification as the windows, except the front door, which is steel-clad reclaimed wood with steel hardware, and the interior doors, which are wood finished in lime paint with a wax sealer

French door out of the kitchen

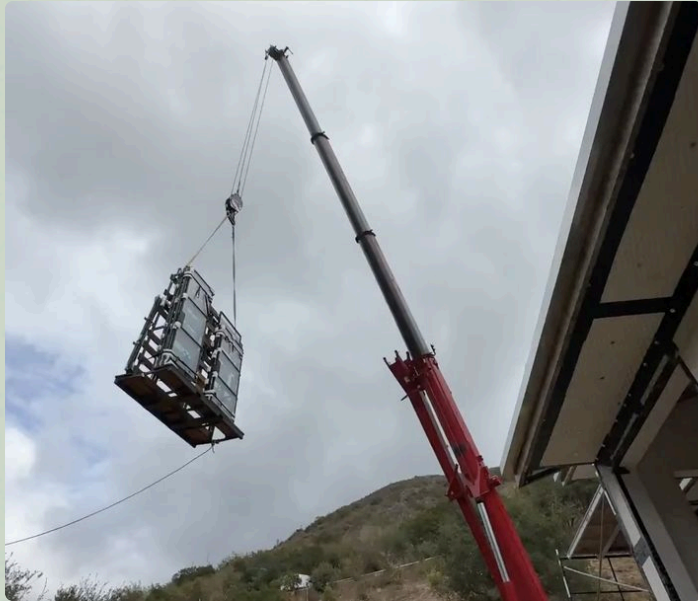
A finished window unit, craned into its opening

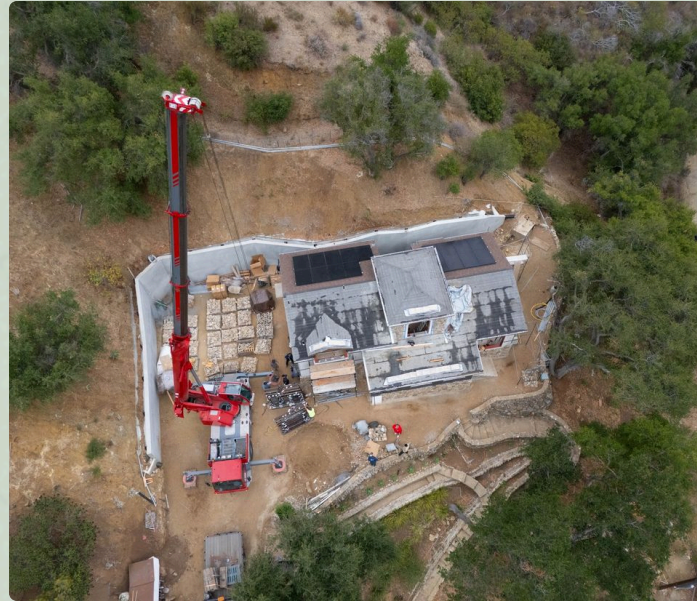
A crane was needed to lift the window over the house

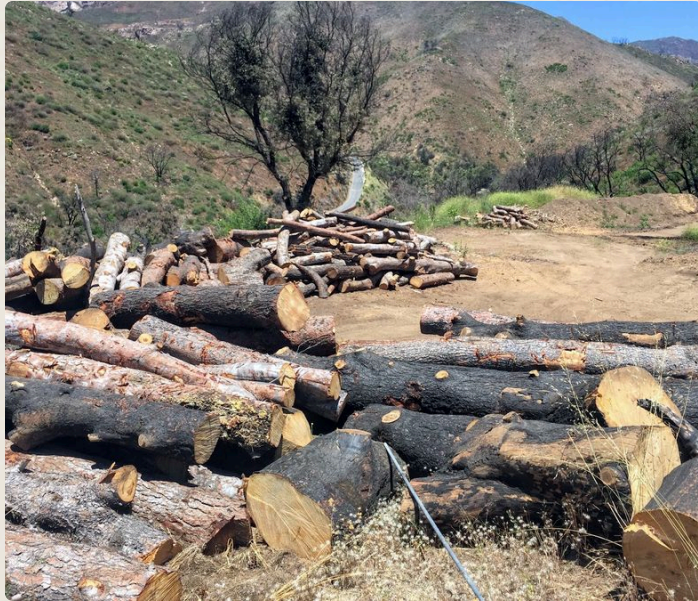
Our fire-destroyed Aleppo pine, cut and staged, ready to be milled into planks on our portable mill

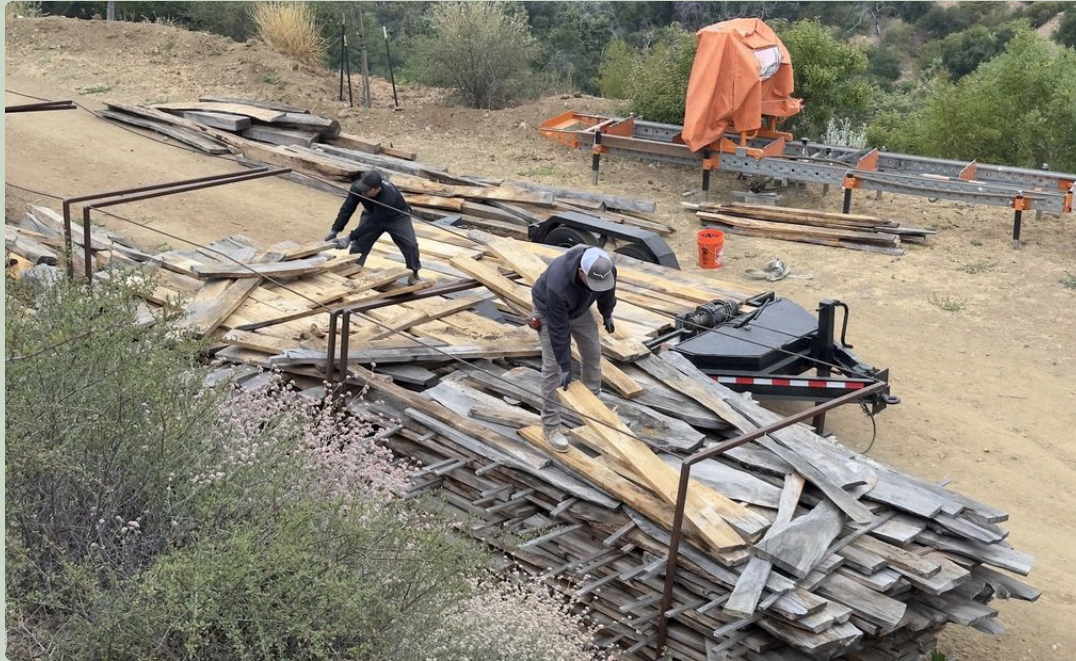
Rough-cut Aleppo pine slabs get selected for milling into flooring at a local facility

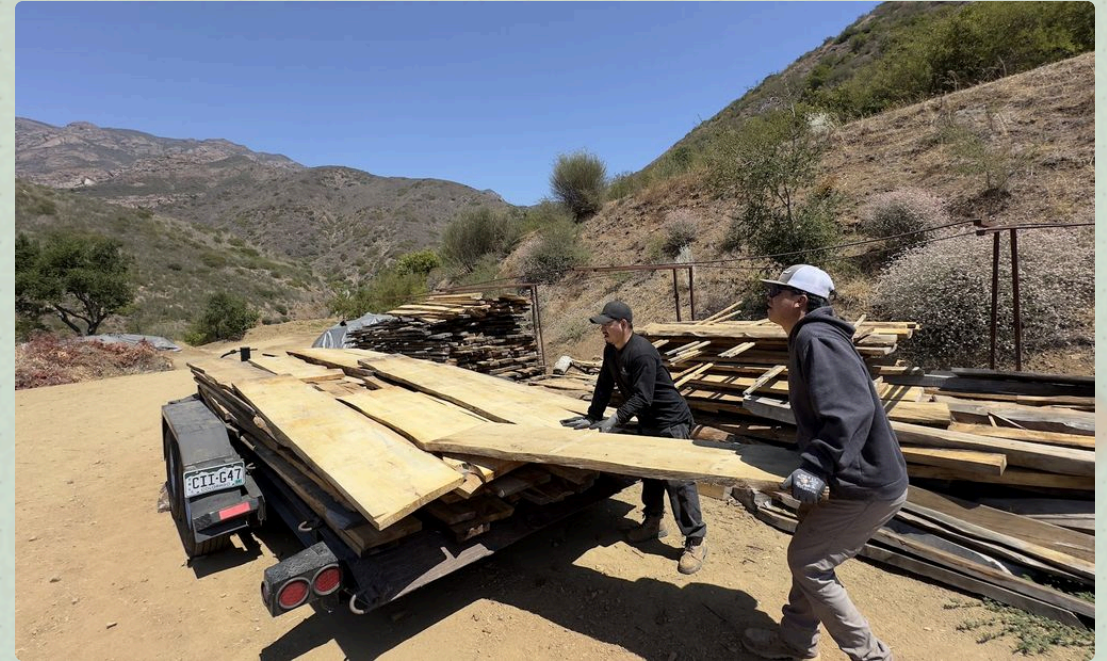
These planks that have been drying for a few years will be made into our living-room, bedroom, hall and closet flooring

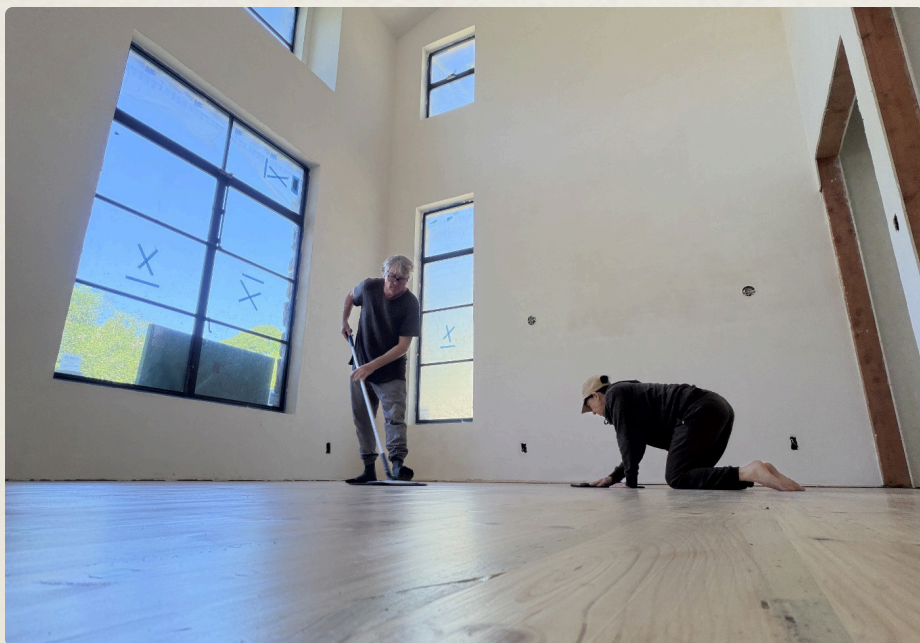
# Flooring for living room, kitchen, bedroom, hall

Wood floor made from 50+ year old Aleppo pines that died and had to be cut down on our property as a result of the smoke and heat from the fire. Finished with Bona Traffic HD over Bonaseal (water-based poly). Moisture barrier (Bona Rollguard Heat) used on slab under wood.

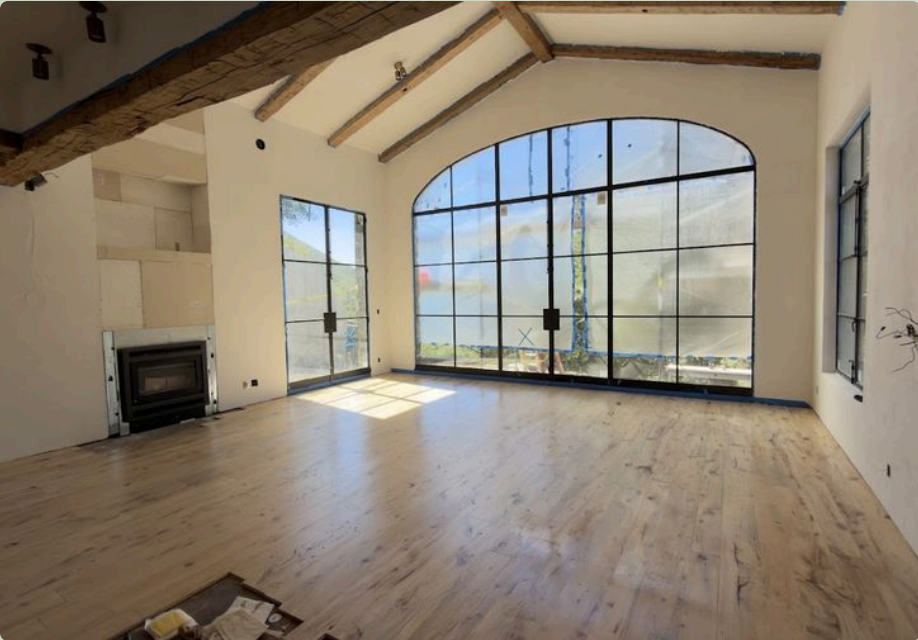
# Wood beams

Wood from the property's own dead trees, plus reclaimed wood from old barns, fabricated into beams.

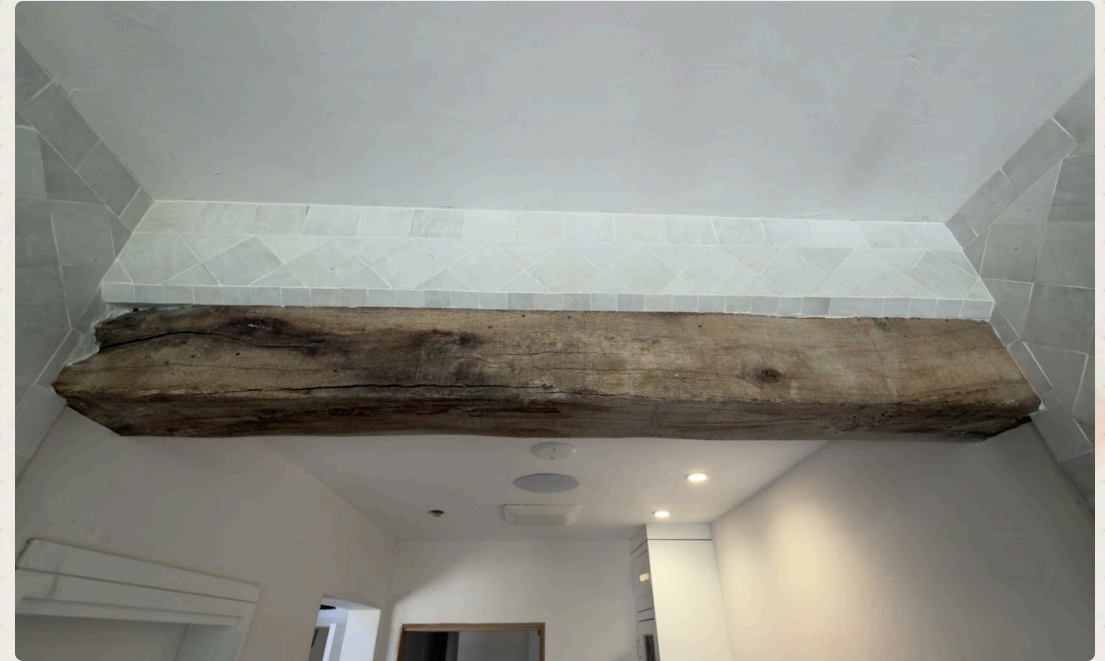
Beam we milled onsite from a coastal live oak that we lost in the fire, installed in the bathroom

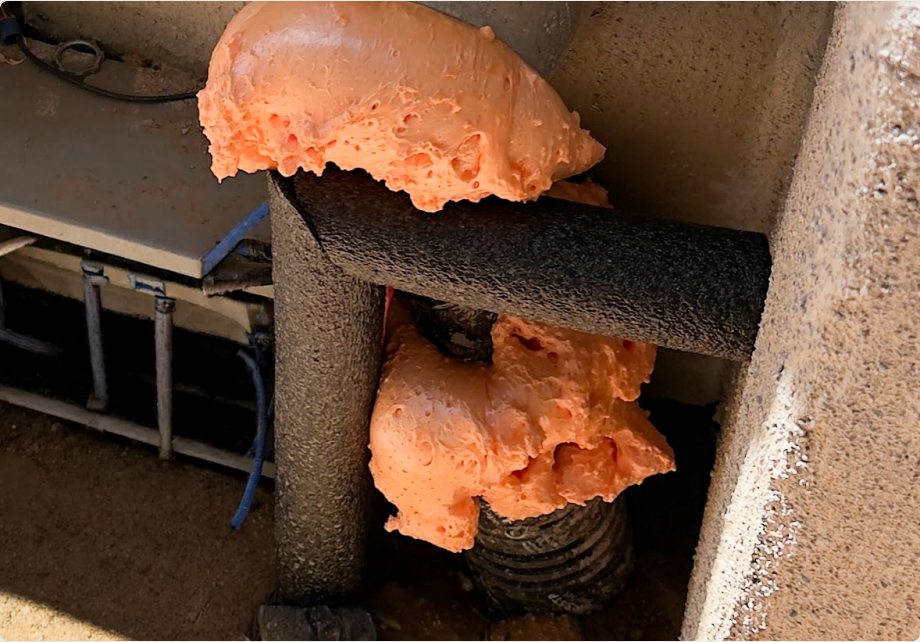
# Fillers

Class A Fire Rated Foam covered in foil for HVAC pipe gaps

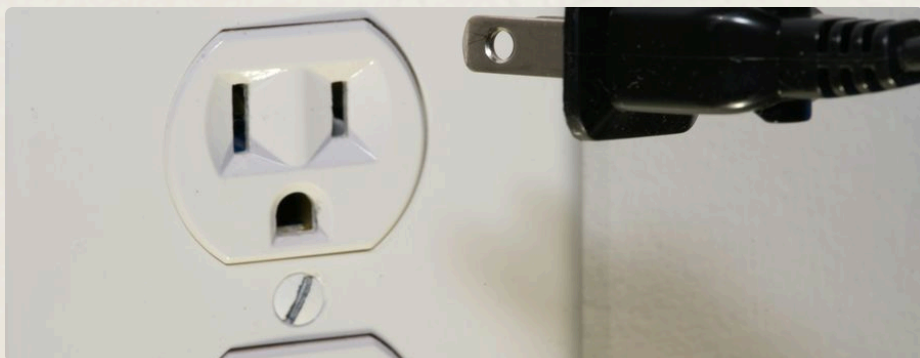
All appliances are electric, with heat pumps for hot water and HVAC.

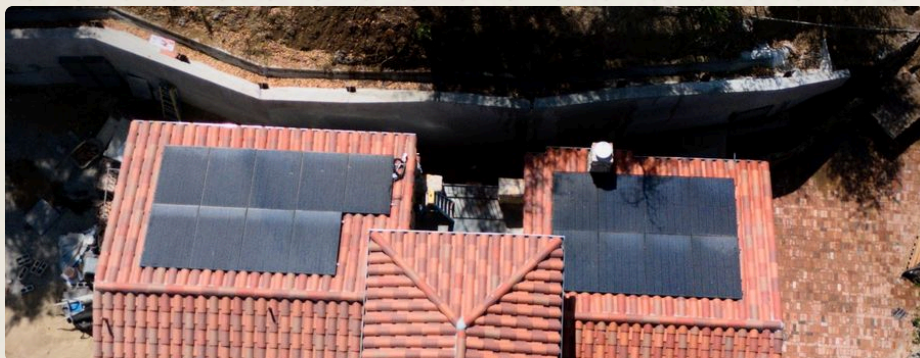
7.5 kW solar PV and 30 kWh battery, with bidirectional EV charging.
